# 8 Dolphin Street YEPPOON QLD 4703

Report Prepared: 19-Jan-22  
Inspector: Karen Logan  
QBCC Licence: 79725

# BUILDING REPORT

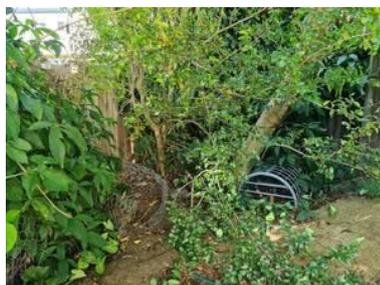
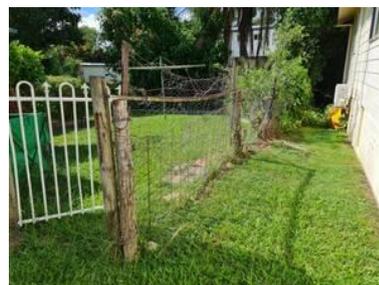
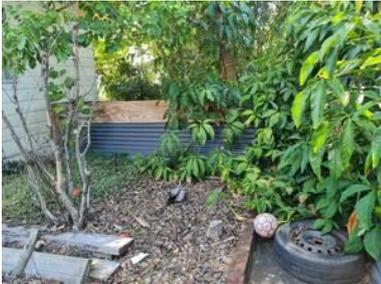
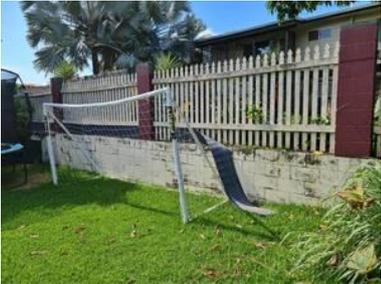
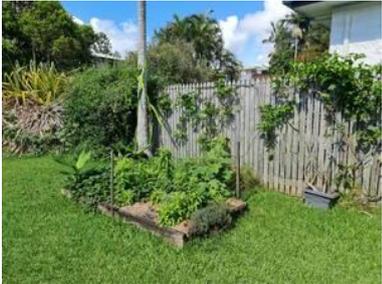
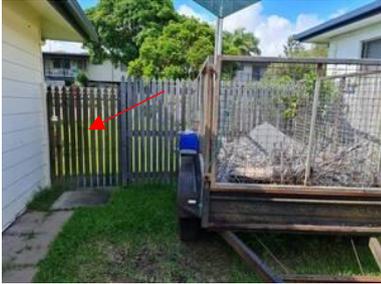
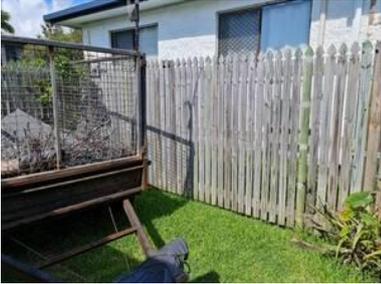
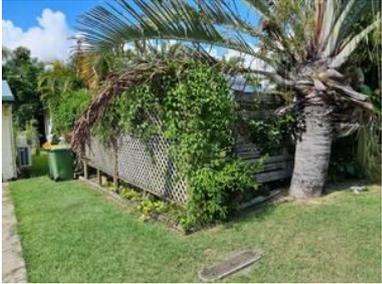
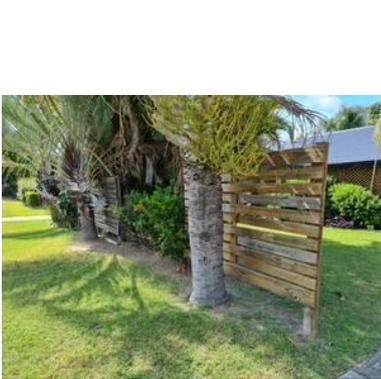
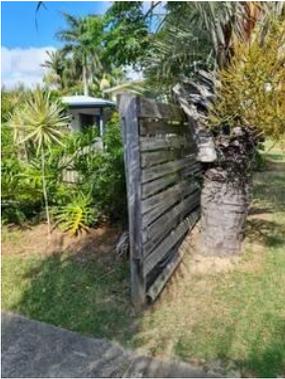
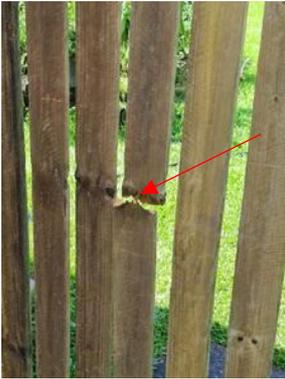
- Comments –
  - There is significant deterioration to the L/H side fence that would benefit from repair
  - There is damage to the R/H side gate requiring repair

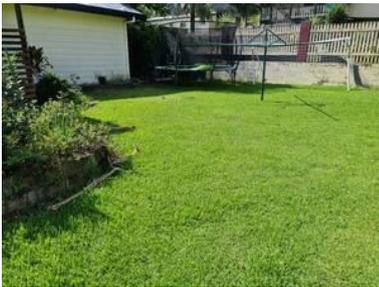
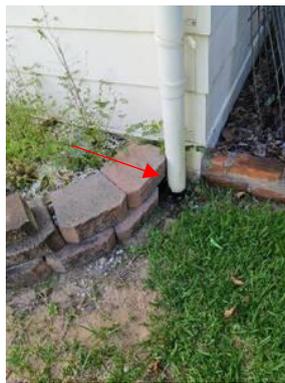
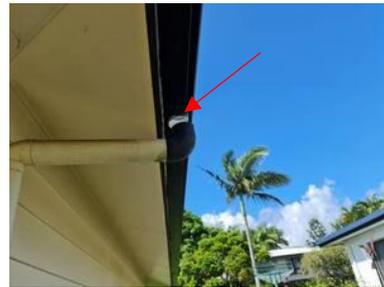
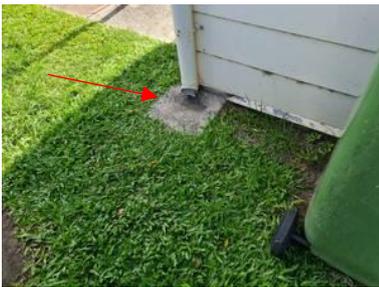
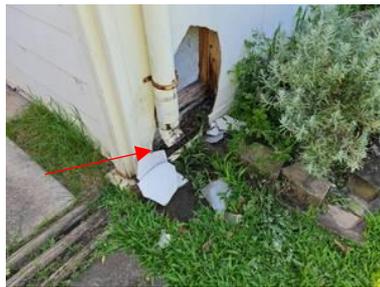
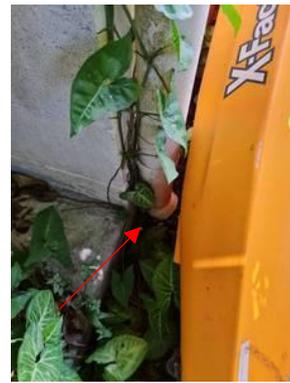
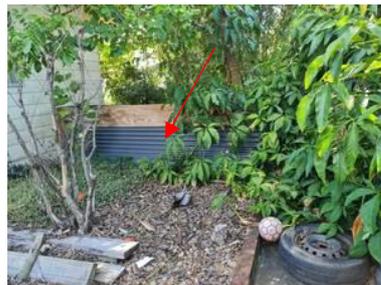
- Comments –
  - Surface water most likely flows through the yard toward the drain located at the rear L/H corner of the property – the fencing applied to the area at the rear of the building to the rear boundary fence appears to prevent water flow to the drain – highly recommend consultation with a structural landscaper or licenced plumber for further assessment and recommendation to ensure water is adequately diverted to the drain in order to prevent further building subsidence, damage to the building elements and attraction of termites
  - The downpipes dispersing water directly beside the building would benefit from further diversion to prevent building subsidence, damage to the building elements and attraction of termites

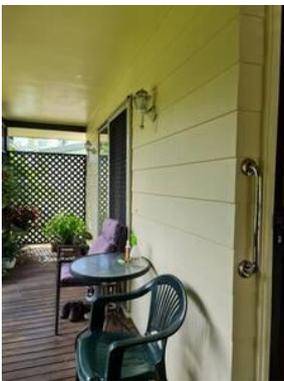
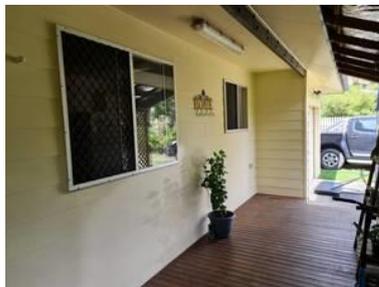
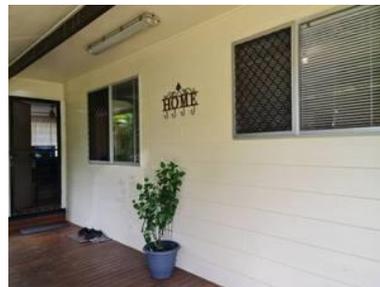
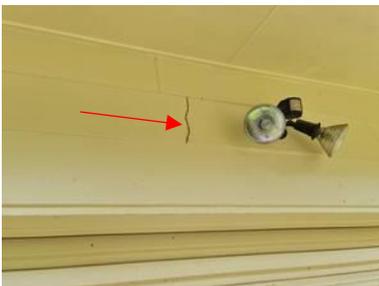
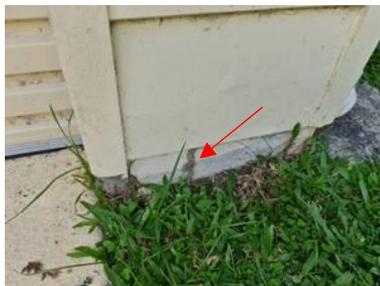
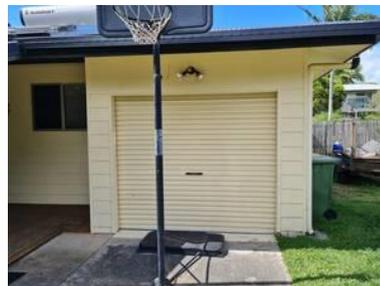
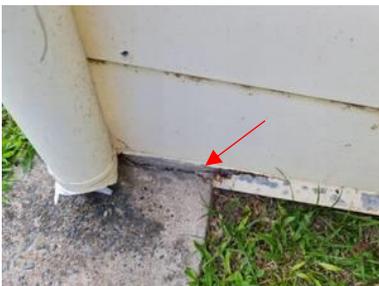
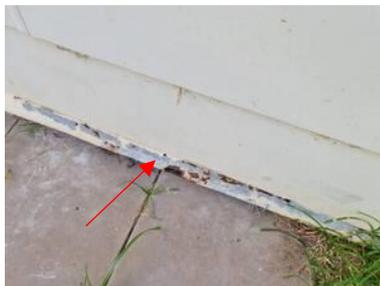
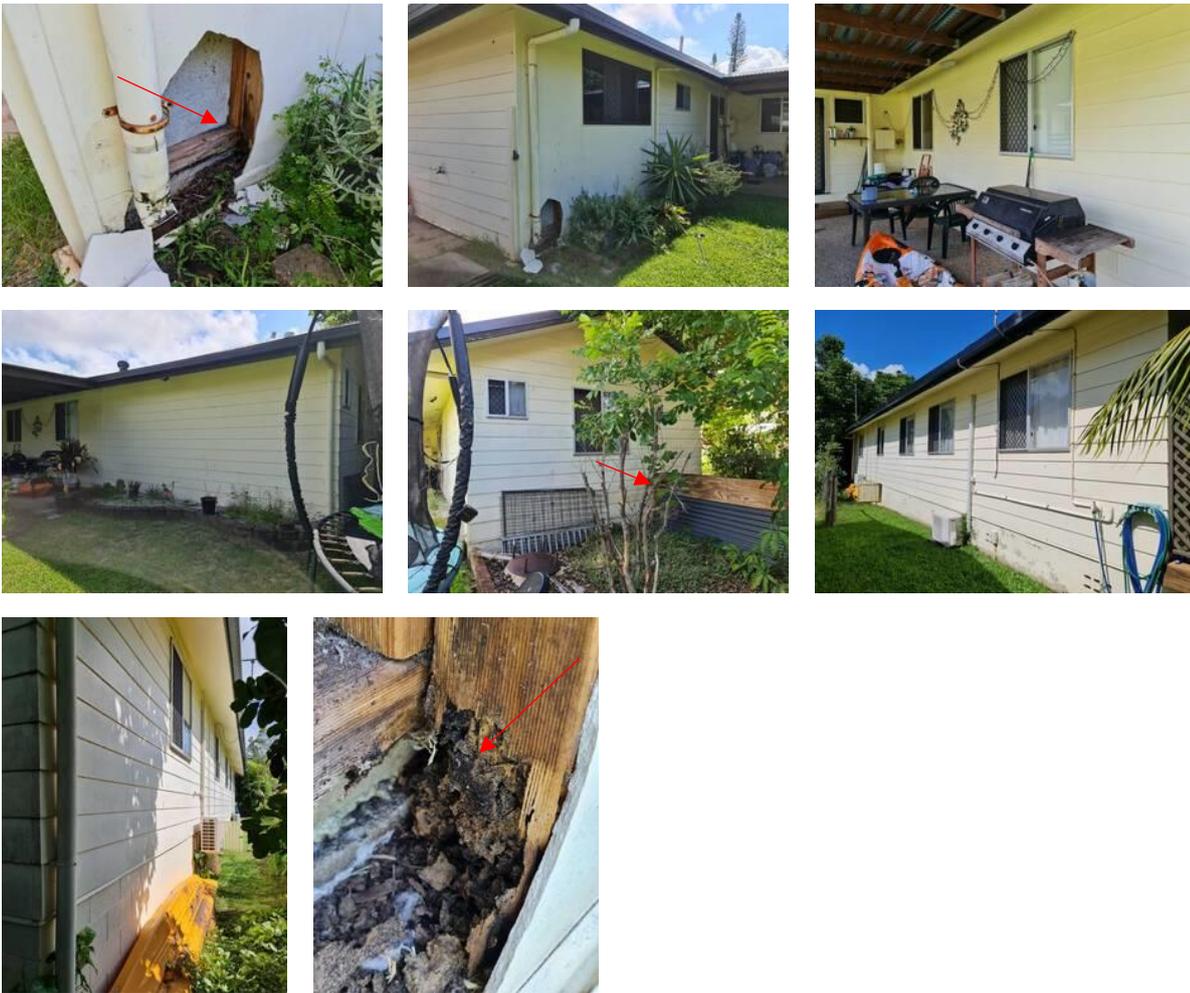
- Comments –
  - There is visible evidence of termite activity in several areas of the building – further invasive inspection would be required to determine the extent of the damage and a course of action as required – also highly recommend consultation with a licenced timber pest specialist for further assessment and recommendation
  - There is damage to the ant capping at the base of the walls that would benefit from repair – an alternative termite barrier could be a consideration
  - There is damage to the wall cladding at the rear of the bathroom requiring repair – further invasive inspection would be required to determine the extent of the damage and a course of action as required - there is visible evidence of termite activity in the wall framing – highly recommend consultation with a licenced timber pest specialist for further assessment and recommendation

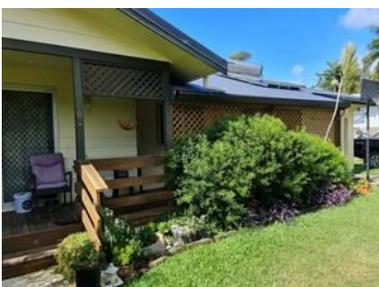
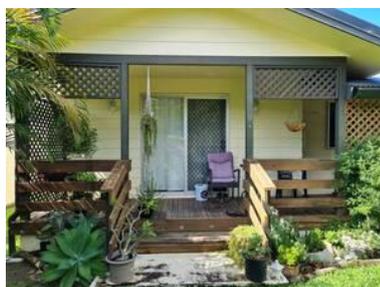
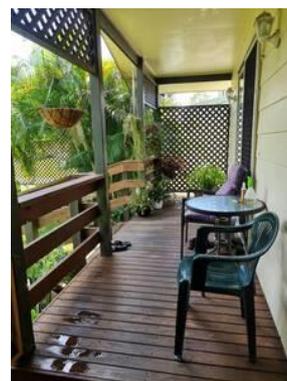
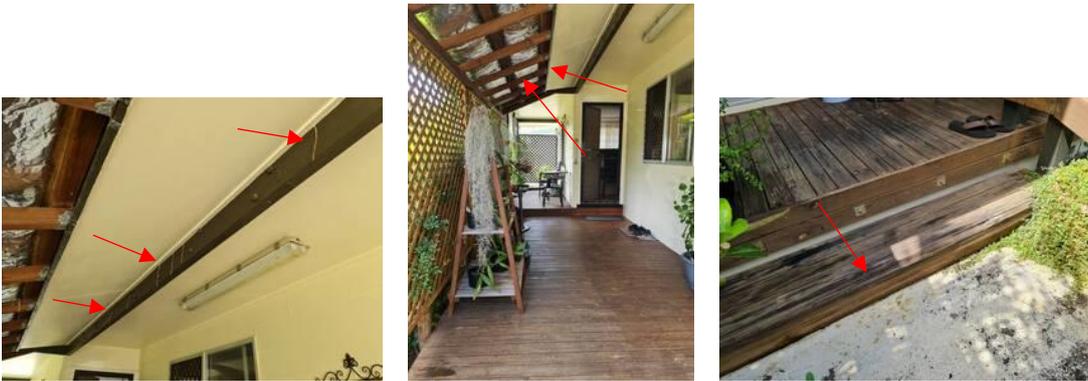
- Comments –
  - There is visible evidence of termite activity on the support beam and timber fascia – further invasive inspection would be required to determine the extent of the damage and a course of action as required – also highly recommend consultation with a licenced timber pest specialist for further assessment and recommendation
  - The ceiling lining appears incomplete – installation of lining could be a consideration
  - There is damage to the front steps requiring repair

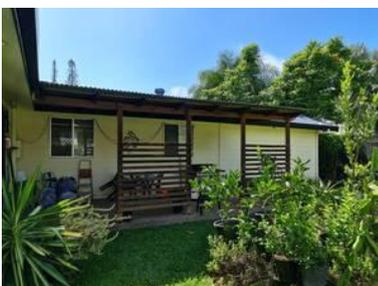
- Comments –
  - The pergola structure appears to have been constructed for a slat roof only – the installation of roof sheeting most likely requires the structure to be upgraded to prevent uplift during serious weather events – highly recommend consultation with a structural engineer to determine structural adequacy
  - The installation of a gutter and drainage would be beneficial to adequately divert water away from the building

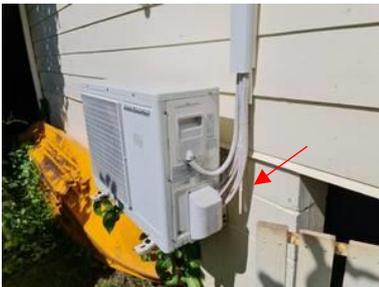
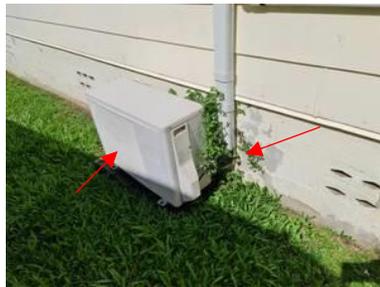
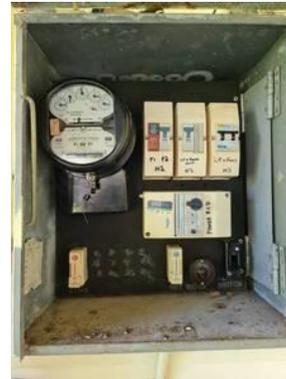
- Comments –
  - Split system air conditioning is installed
    - Air conditioning drains dispersing water directly beside the building would benefit from further diversion to prevent building subsidence, damage to the building elements and attraction of termites
    - One of the air conditioners is out of level requiring re-positioning

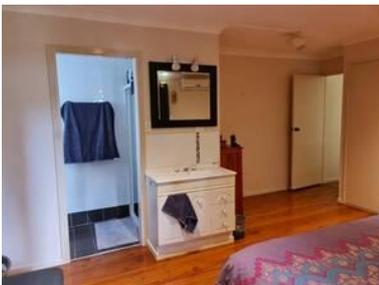
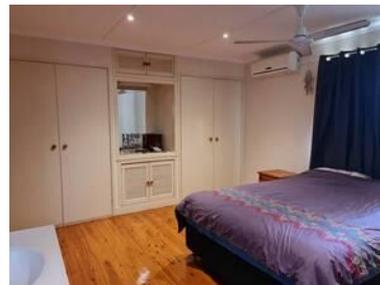
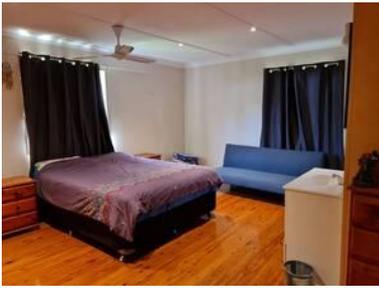
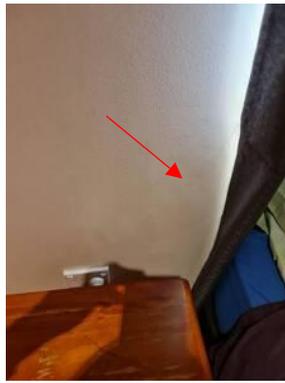
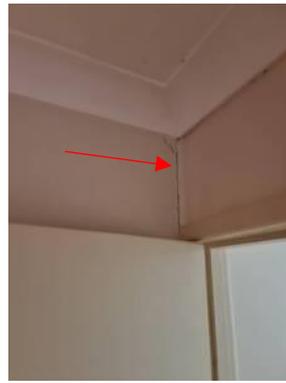
- Comments –
  - There is some evidence of movement cracking in the wall linings requiring repair – consultation with a structural engineer would be required to determine the significance of the cracking and a course of action as required – also see 'Subfloor'

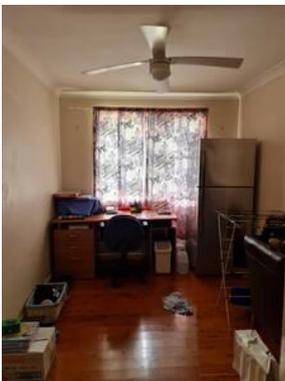
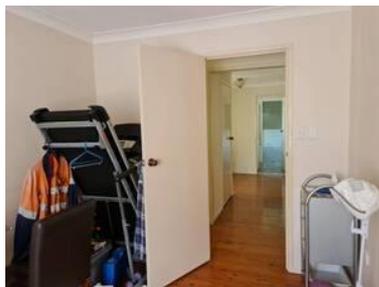
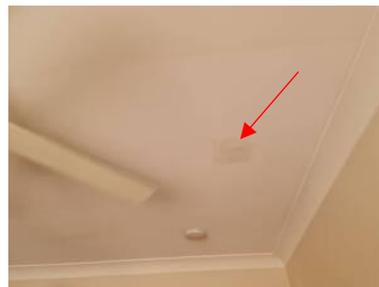
- Comments –
  - There is some damage to the ceiling lining that would benefit from repair

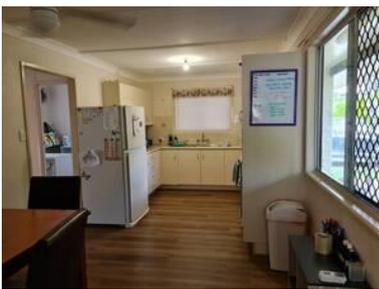
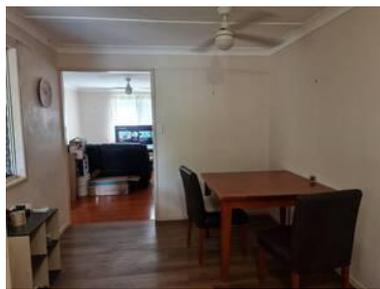
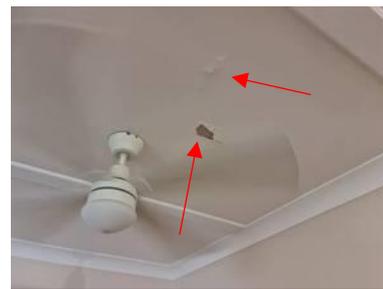
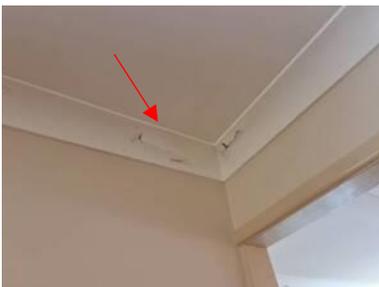
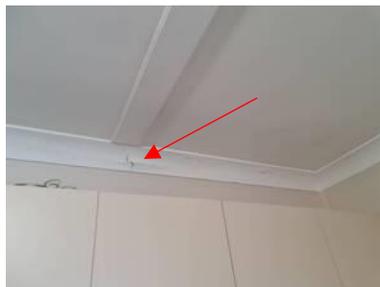
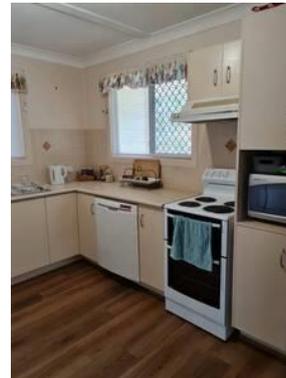
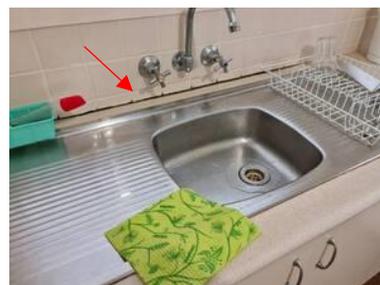
- Appliances (not tested)
  - upright electric stove
  - rangehood
  - dishwasher
- Cabinets - **acceptable**
- Benchtop - **acceptable**
- Splashback - **acceptable**
- Comments –
  - The junction between the benchtop and splashback would benefit from sealing to prevent damage to the benchtop, cabinets and walls
  - There is damage to the paint finish to the ceiling lining and cornice requiring repair

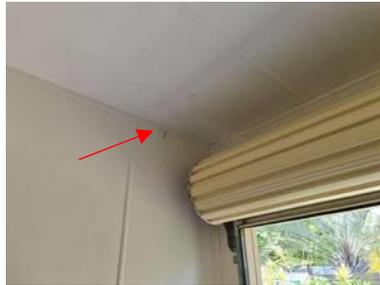
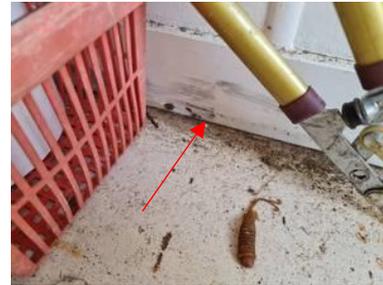
- Comments –
  - There is evidence of termite activity in the skirting board and to the top of the wall adjacent to the roller door – further invasive inspection would be required to determine the extent of any damage and a course of action as required – highly recommend consultation with a licenced timber pest specialist for further assessment and recommendation

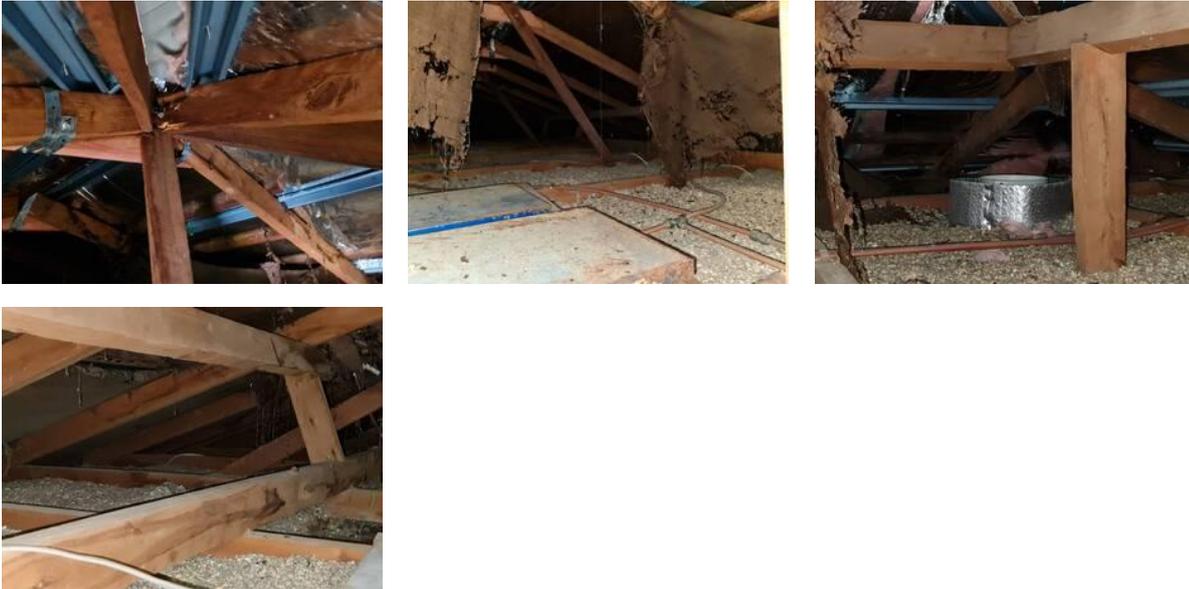
- **Roof Construction – acceptable/fair**
  - Timber Truss Construction
    - There are several split timber members – further assessment of the roof members would be beneficial to determine structural adequacy
- **Roof Covering Underside – not inspected due to the installation of insulation installed under the roof sheeting**
- **Insulation – acceptable**
  - Blow-in-type installed on the ceiling
  - Blanket type installed under the roof sheeting
- **Ceiling – not inspected due to the installation of insulation**
- **Sarking –**
  - The old/redundant sarking remaining in the roof space would benefit from removal to provide adequacy for visual inspections
- **Access - was restricted by insulation installed on the ceiling concealing electrical wiring causing unsafe access**

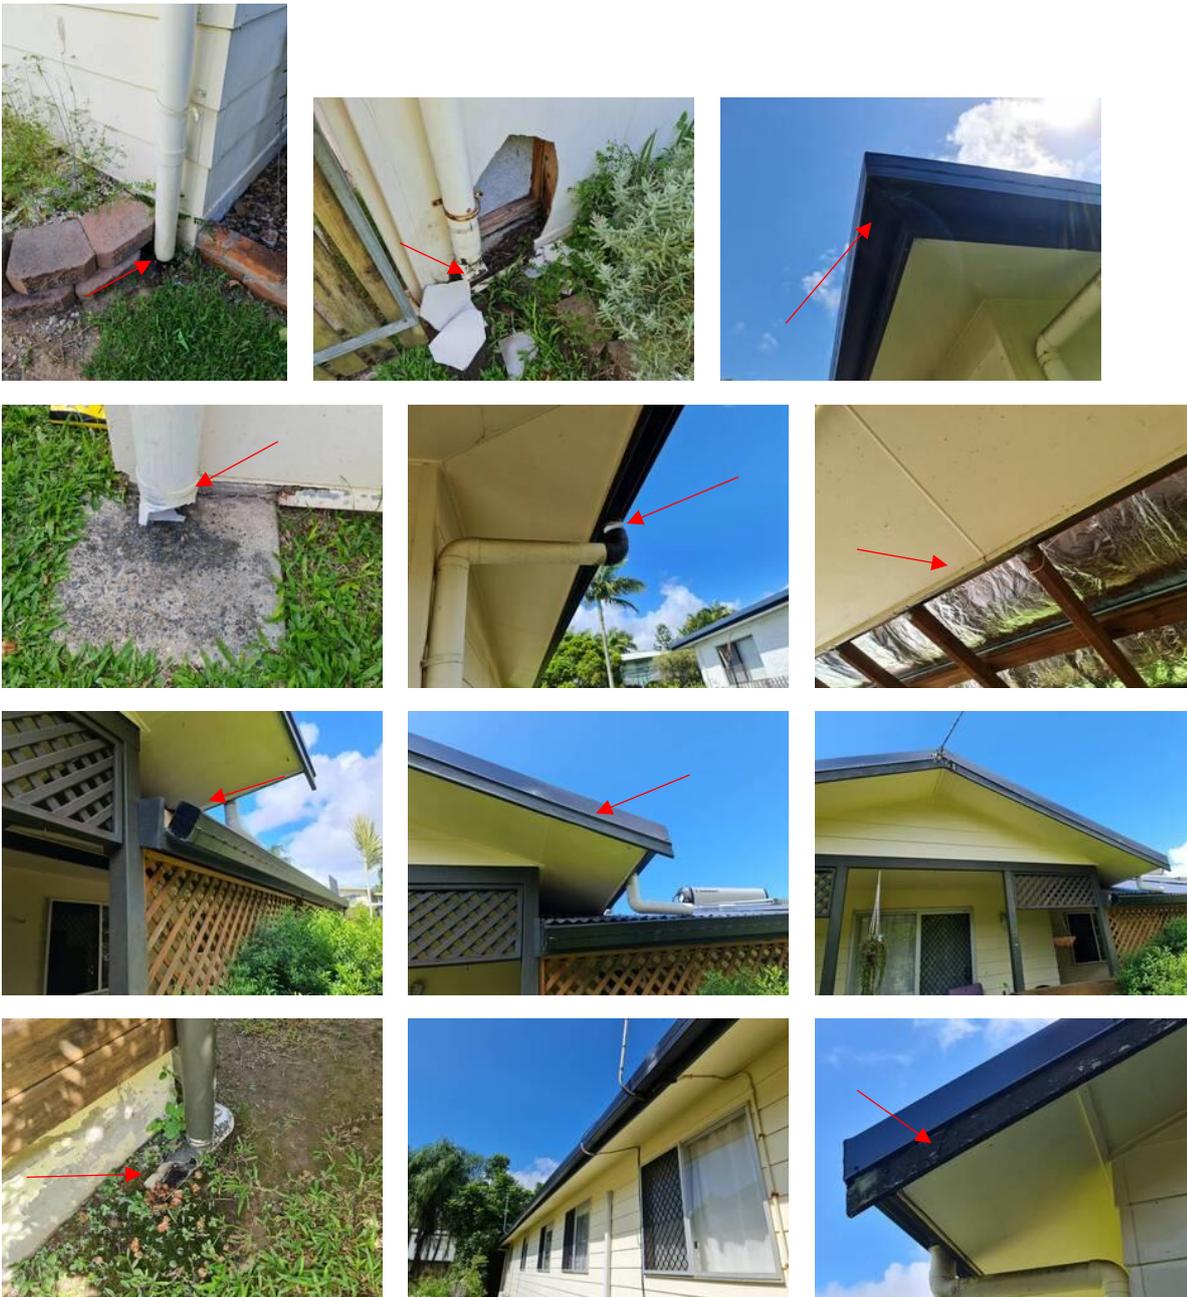
- **Gutters, Downpipes & Flashings – fair/poor**
  - There is a dislodged gutter at the front of the building requiring repair
  - The gutter corner is leaking at the rear R/H side of the building requiring repair

- The downpipe is dislodged at the front R/H side of the building requiring repair
  - There is damage to the base of some of the downpipes requiring repair

- **Eaves, Fascia & Barge Ends – fair**
  - There is some deterioration to the timber fascia requiring repair
  - There is visible evidence of termite activity on the timber fascia in the front verandah area – further invasive inspection would be required to determine the extent of the damage and a course of action as required – also highly recommend consultation with a licenced timber pest specialist for further assessment and recommendation

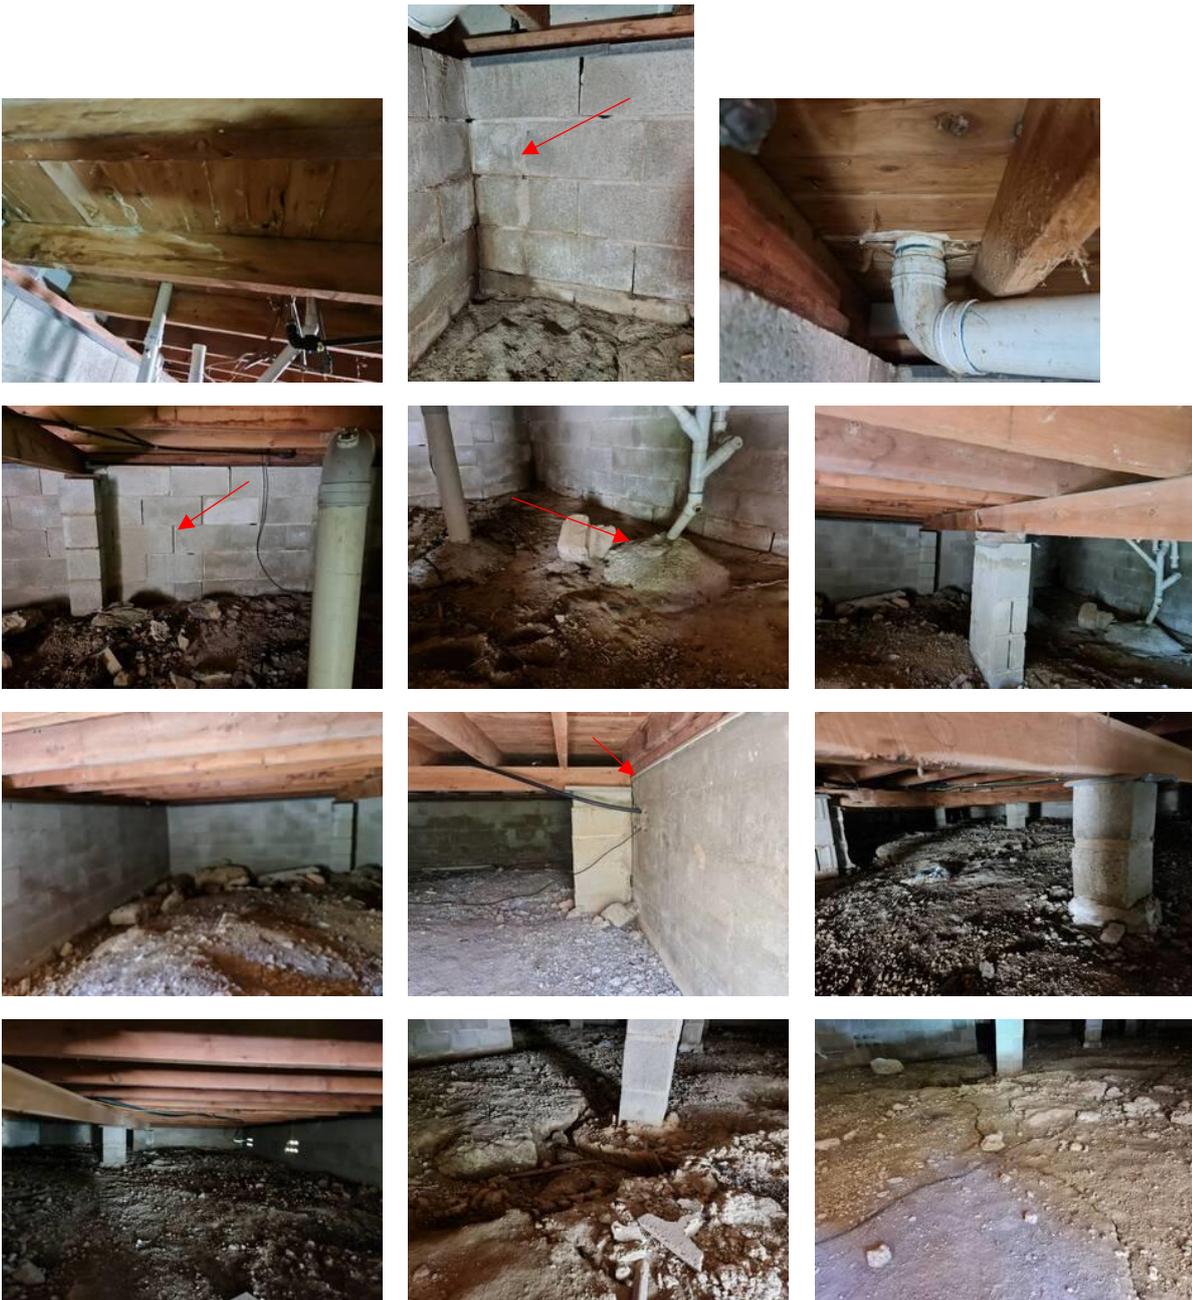
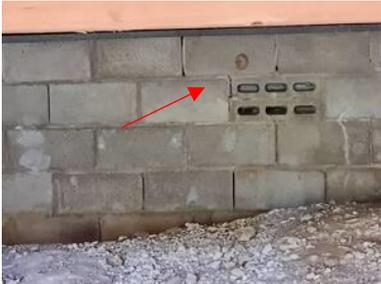
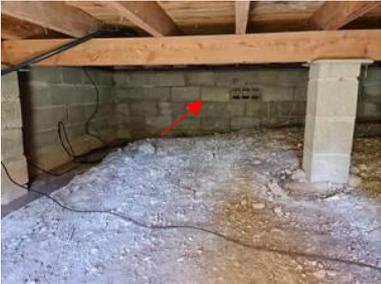
- **Piers/Posts/Supports – fair**
  - There is cracking to the concrete block dwarf walls – consultation with a structural engineer would be required to determine the significance of the damage and a course of action as required
- **Bearers & Joists – acceptable**
  - Timber bearers and joists
- **Underside of Flooring – acceptable**
  - Timber strip flooring
- **Ventilation – poor**

- There appears to be insufficient ventilation to the area – recommend consultation with a structural engineer to determine adequacy
- **Termite Shielding – fair/poor**
  - There is damaged and incomplete physical termite barriers – highly recommend consultation with a licenced timber pest specialist for a termite management plan
- **Access – was acceptable**
- **Comments –**
  - An overflow relief gully is installed under the ensuite bathroom – recommend consultation with a licenced plumber to determine adequate compliance for health purposes
  - *Note: There were areas of the ground in the subfloor remaining wet at the time of inspection – this is most likely as a result of poor surface water drainage and inadequate ventilation*
