20 Smith Road
COOEE BAY QLD 4703

Report Prepared: 18 January 2014
Inspector: Karen Logan

Building Report

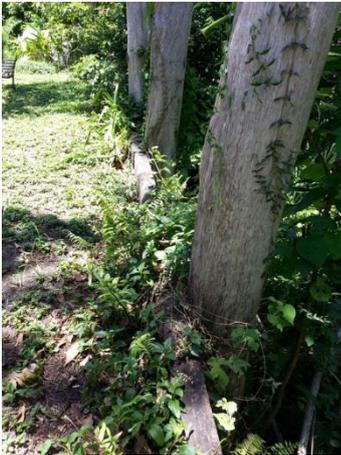
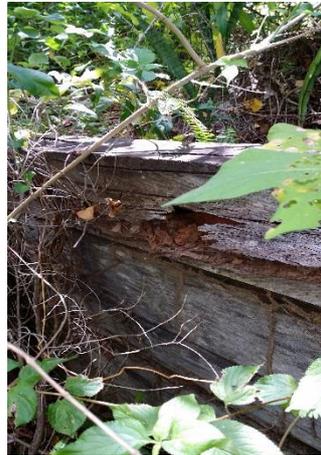
Retaining Walls

Overall condition: partially inspected – foliage reduced ability to inspect

- Comments -
 - The retaining wall on the R/H side of the property does have some significant deterioration requiring repair

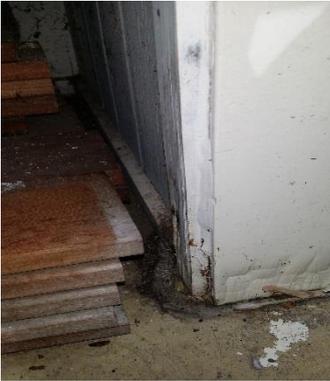
Overall condition: acceptable/fair

- Comments -
 - There is some deterioration of the timber architrave, skirting & jamb requiring repair

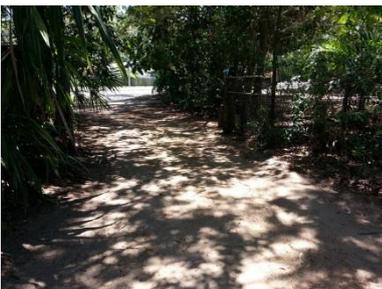
Fences

Overall condition: not inspected, I cannot apply a condition

- Comments -
 - Most of the fences were significantly obscured from view by vegetation - further investigation once, vegetation was removed, would be beneficial to determine the condition of the fencing

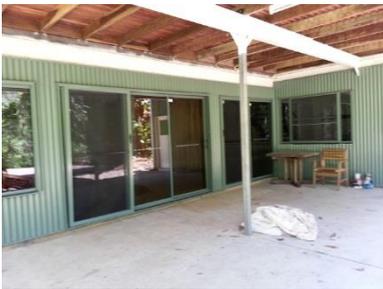
External Walls

- Comments -
 - The installation of blocking between the joists at the area under the front upper floor entry and the rear verandah would be beneficial to prevent access by vermin to the lower floor ceiling
 - There is some minor deterioration of the weather boards at the external corners – recommend maintaining paint finish to prevent further deterioration

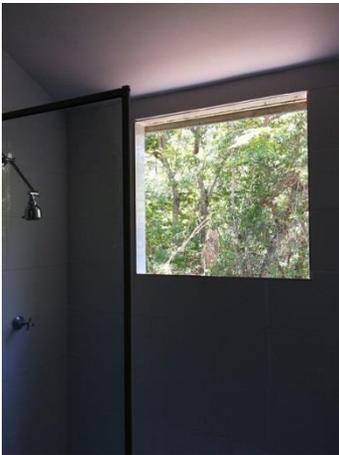
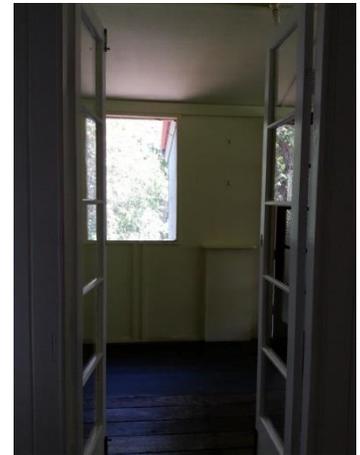
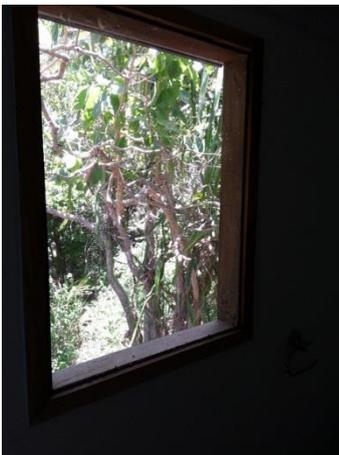
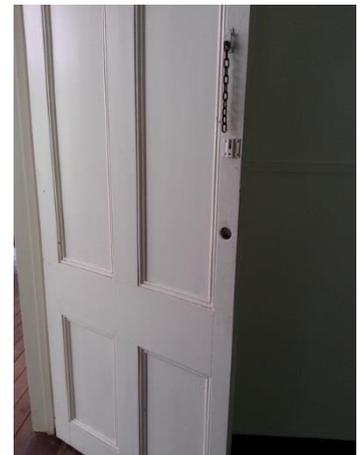
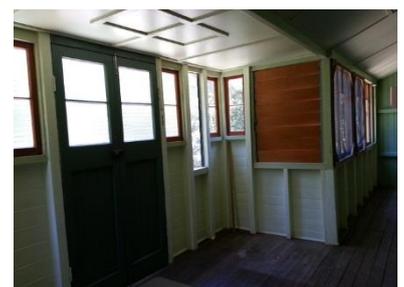
External Doors & Windows

Overall condition: acceptable/fair

- Comments -
 - There are missing windows to the upper floor toilet, enclosed verandah & bathroom requiring installation to prevent water from entering the building
 - There is broken glass to the windows at the dining area & kitchen requiring repair
 - There is missing window latches to the kitchen windows facing the verandah
 - The flyscreen frame is binding on the wall at the dining room
 - There is door furniture missing to the door opening from the dining room/stairs to the verandah that would benefit from installation
 - The door from the laundry requires painting
 - The front entry door lock to the upper floor was not operational at the time of inspection requiring repair

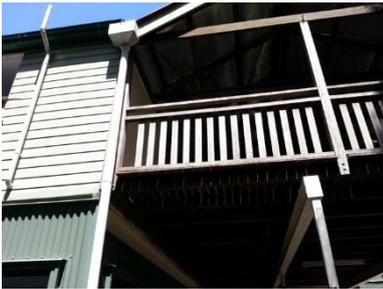
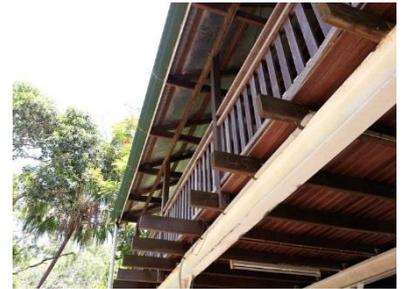
Verandah – Upper Level

Overall condition: acceptable/fair

- Comments -
 - There is a baluster missing to the balustrade requiring installation
 - The gable end over the kitchen windows is incomplete requiring completion
 - The joists protruding from the verandah would benefit from cutting for aesthetic purposes

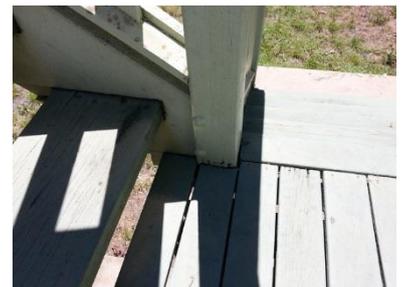
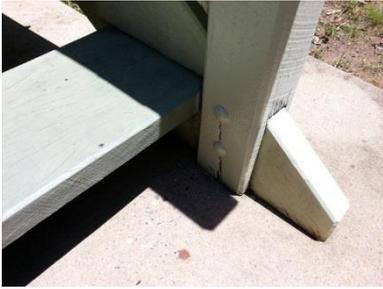
Overall condition: acceptable/fair

- Comments -
 - There is a baluster missing requiring installation
 - There is some minor deterioration of the base of the post at the landing that would benefit from repair
 - The newel posts are cracked at the base of the stairs – recommend monitoring for any further deterioration or movement and repair as required
 - The top of the stairs at the entry doors requires the installation of a nosing board for completion

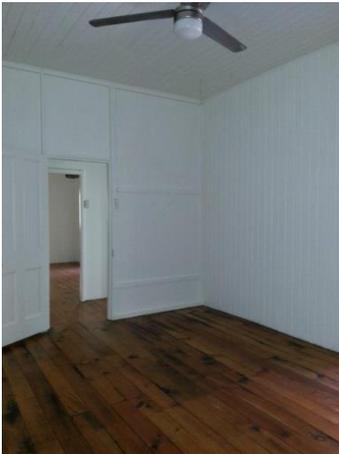
Overall condition: acceptable/fair

- Comments -
 - There is damage and excessive flex in some of the flooring most likely caused by damage to the tongue and grooves of the flooring boards that may not withstand heavy point loads – recommend consultation with a licenced builder for further assessment and repair as required

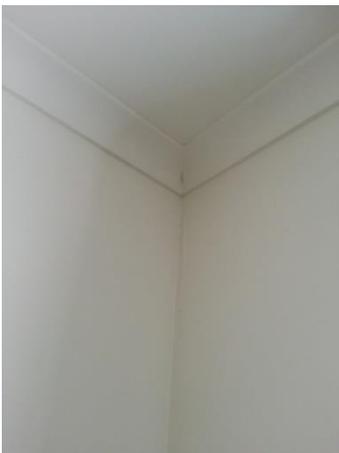
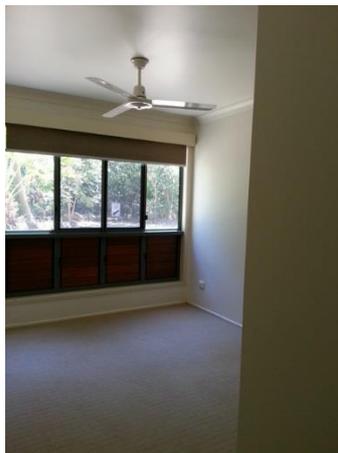
Overall condition: acceptable

- Comments -
 - There is some minor distortion of the plasterboard in the top L/H corner of the room that would benefit from repair on the next re-paint – also recommend monitoring this area for any further deterioration
 - The wardrobe would benefit from the installation of doors to protect contents from dust and sunlight

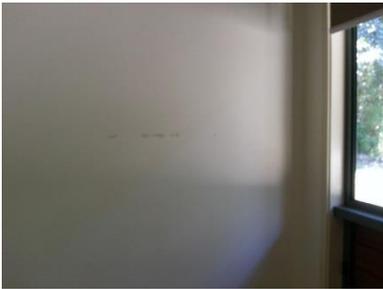
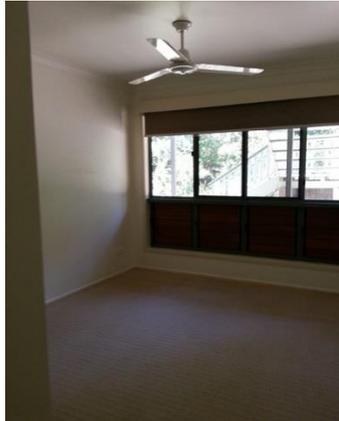
Bedroom 4 – Lower Level

- Comments -
 - The wardrobe would benefit from the installation of doors to protect contents from dust and sunlight

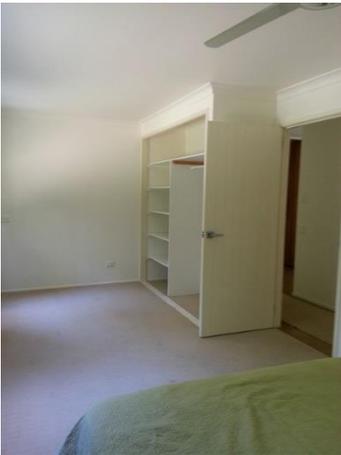
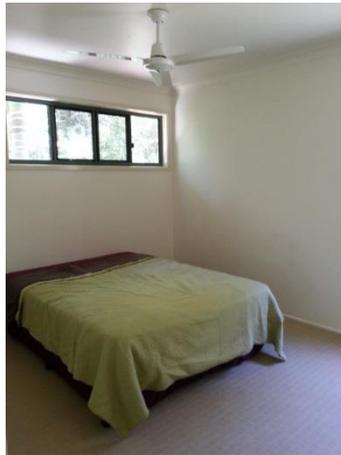
Bedroom 5 – Lower Level

- Comments -
 - The wardrobe would benefit from the installation of doors to protect contents from dust and sunlight

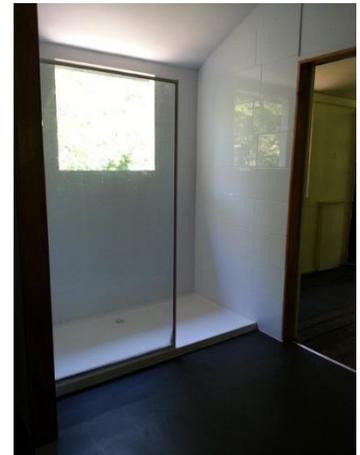
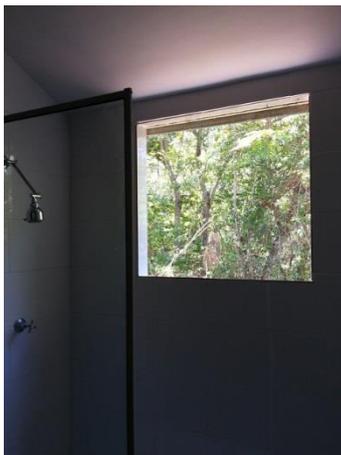
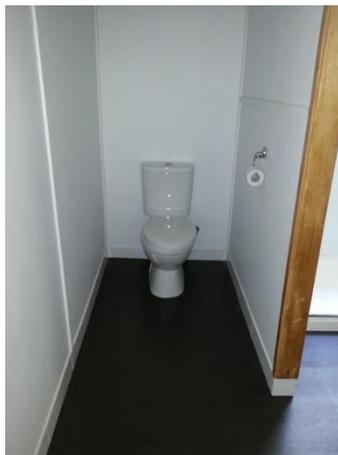
Bathroom – Upper Level

Overall condition: acceptable/fair

- Comments -
 - This bathroom appears to have been recently renovated however it appears that no consideration has been made for waterproofing – the area appears to rely heavily on the seals around the vinyl floor covering to prevent water from affecting the ceiling below, the flooring & timber bearers & joists and the adjacent flooring in the enclosed verandah – regular monitoring of the seals and vinyl would be required to prevent water damage
 - Generally a window is required to prevent water from entering the building
 - There is a tile missing behind the toilet that would benefit from installation

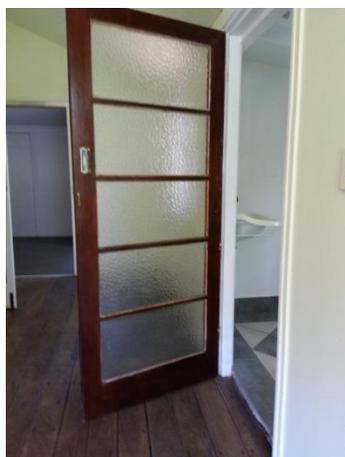
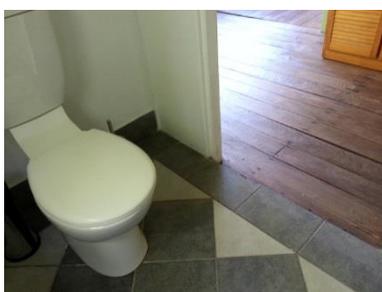
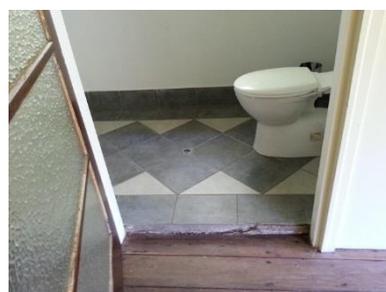
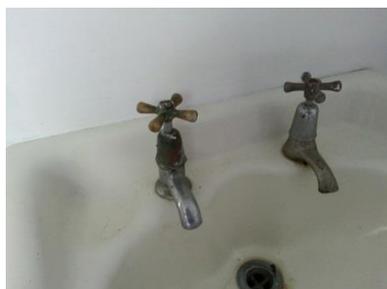
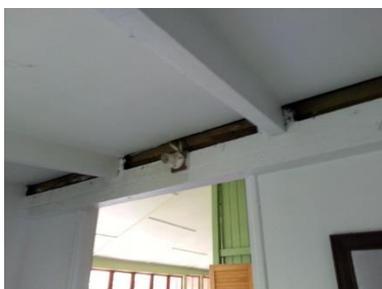
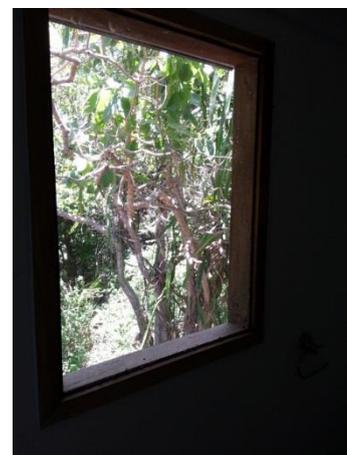
Toilet – Upper Level

Overall condition: fair

- Comments -
 - The door is binding on the door jamb requiring adjustment
 - The skirting tiles are incomplete and would benefit from completion
 - The junction between the wall and ceiling is incomplete requiring a finishing moulding
 - Generally a window is required to prevent water from entering the building
 - There is some deterioration of the taps and basin however still functional

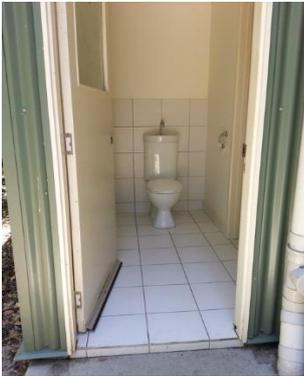
Toilet 2 – Lower Level

Overall condition: acceptable/fair

- Comments -
 - There is some deterioration of the architrave at the base of the door jamb requiring repair

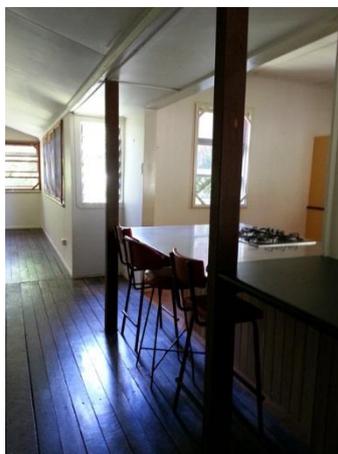
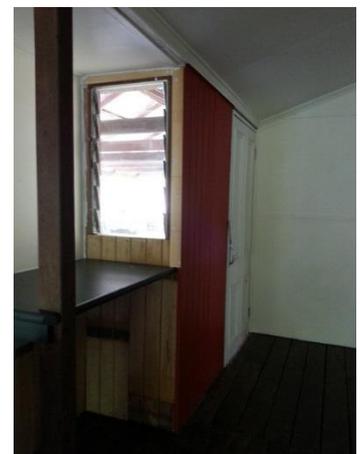
Kitchen – Upper Level

- Appliances - not tested -
 - under bench oven
 - gas cook top
- Cabinets - acceptable
- Benchtop - acceptable
- Splashback - acceptable
- Comments -
 - Some areas of the walls, posts and cabinets are un-painted and would benefit from completion
 - Also see 'External Doors and Windows'

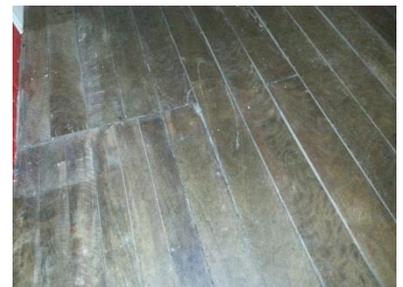
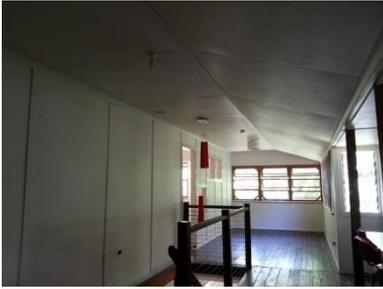
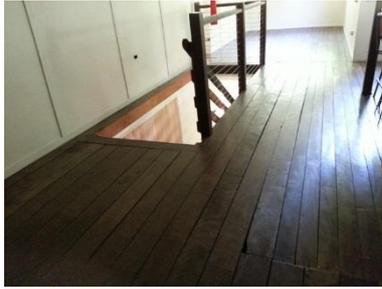
Overall condition: acceptable/fair

- Comments -
 - The flyscreen frame is binding on the window requiring repair
 - The wall over the internal stairs requires patching and re-painting
 - Generally the floor boards are rough sawn causing the floor to be of an uneven finish with excessive gaps which may allow water and dust etc. to affect the ceiling below some of the boards are loose and or damaged requiring repair – consideration may be given to replacing this flooring

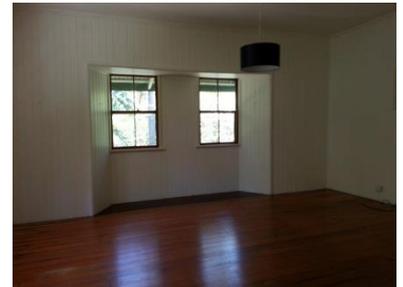
Living Room – Upper Level

- Comments -
 - The door furniture requires adjustment for effective operation
 - There is a hole cut in the wall lining that would benefit from finishing mouldings

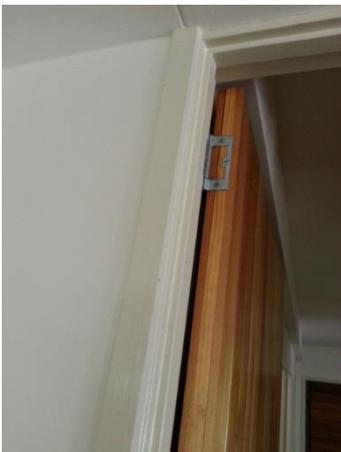
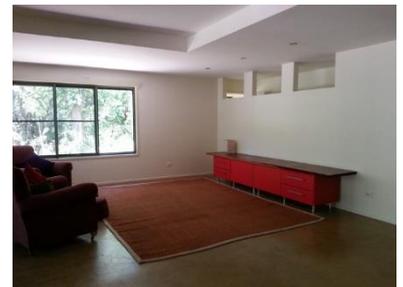
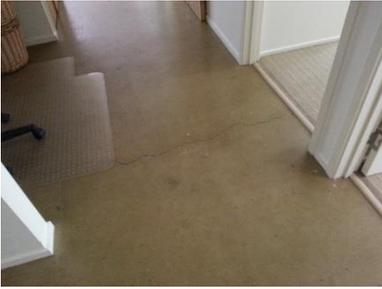
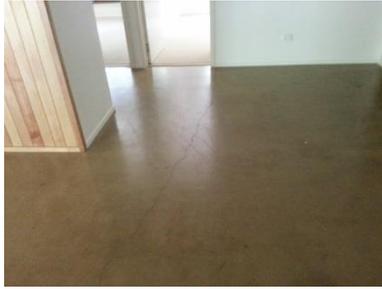
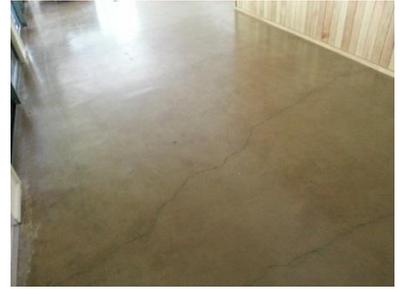
Living Room 2 – Lower Level

Overall condition: acceptable/fair

- Comments -
 - There is some delamination of the door to the study nook caused by the hinge screws requiring repair
 - There are some significant cracks to the concrete floor– recommend monitoring these cracks for any further deterioration

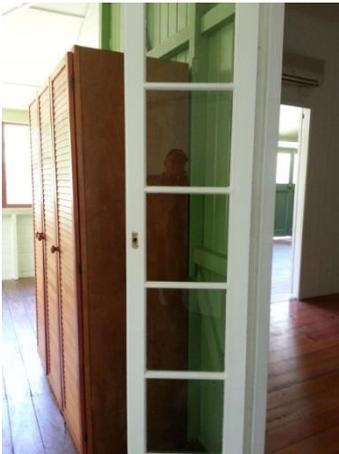
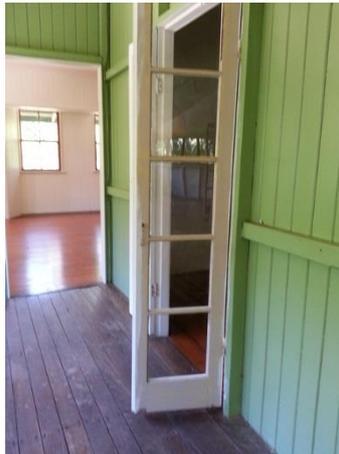
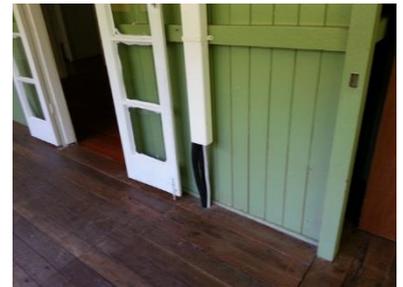
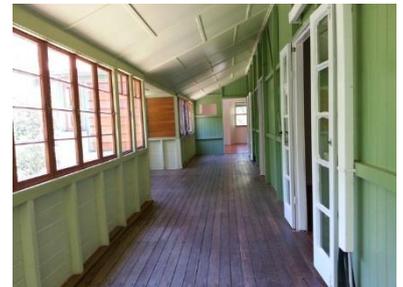
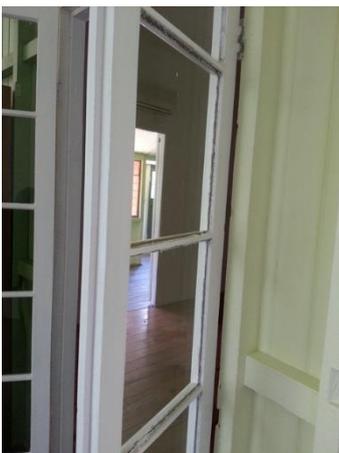
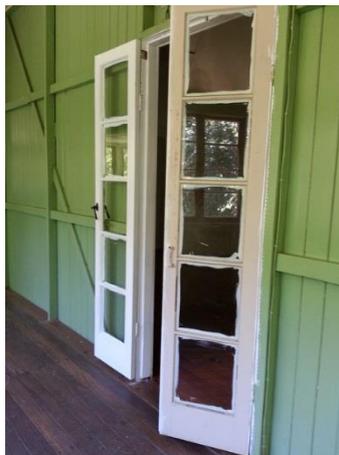
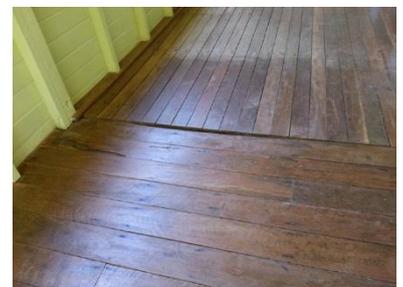
Enclosed Verandah Room

Overall condition: acceptable/fair

- Comments -
 - The floor boards at the toilet/bathroom end of the enclosed verandah are rough sawn causing the floor to be of an uneven finish with excessive gaps which may allow water and dust etc. to affect the ceiling below some of the boards are loose and or damaged requiring repair – consideration may be given to replacing this flooring

- There is a significant lip to the flooring (pictured below) that would benefit from repair
 - Generally the french doors have only been partially re-painted. Some of the doors require new putty to be installed and there is a missing glass pane to the door for bedroom 2 requiring replacement. Most of the doors require the installation of door latches etc.

- The air conditioning conduit would benefit from extension to the floor to protect the pipes and power cable

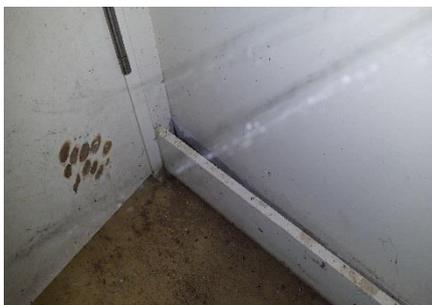
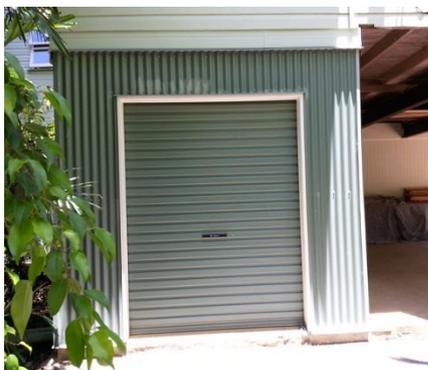
Store Room

- Comments -
 - The skirting board beside the pedestrian door requires re-fixing

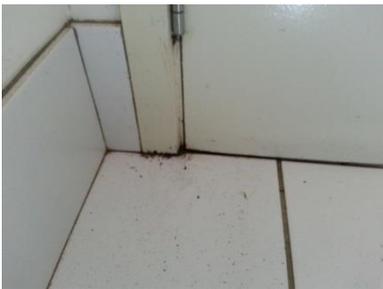
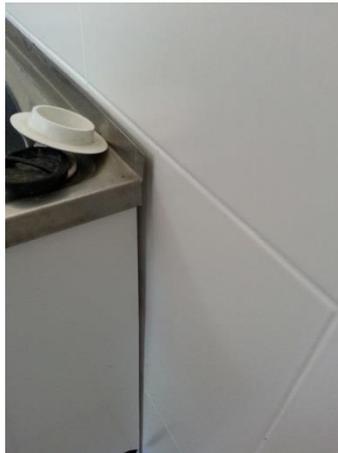
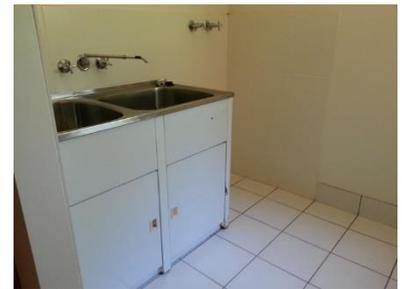
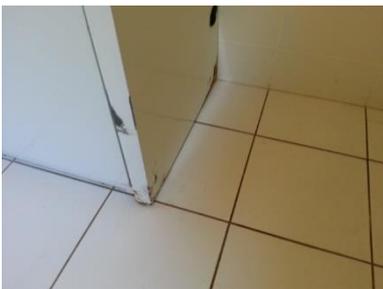
Laundry – Lower Level

Overall condition: acceptable/fair

- Comments -
 - There is some deterioration of the architrave at the base of the door jamb that would benefit from repair
 - The laundry tub requires fixing and sealing to the wall
 - There is some minor deterioration of the laundry tub cabinet that would benefit from rust treatment to prevent further deterioration

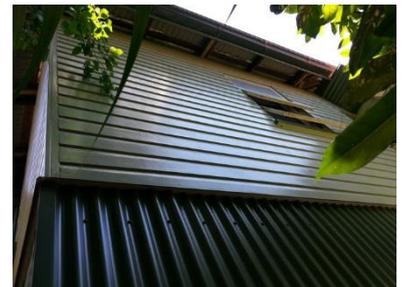
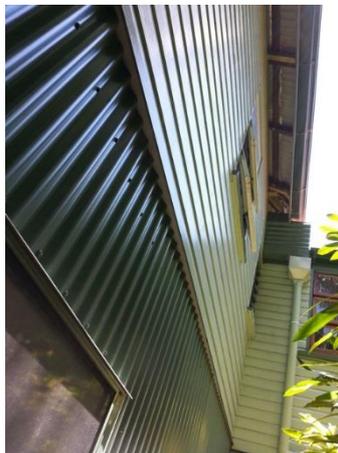
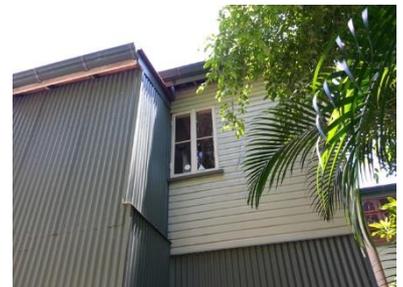
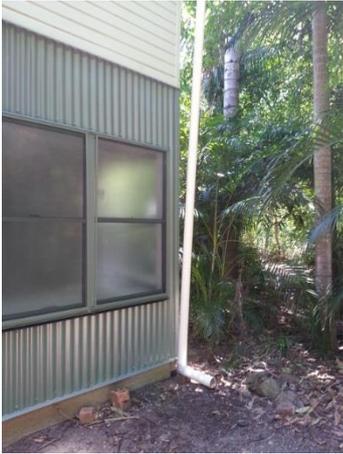
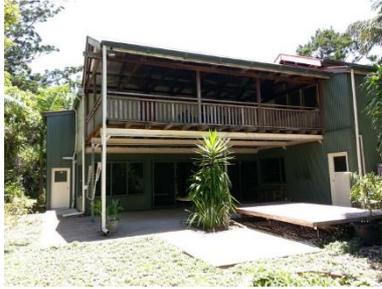
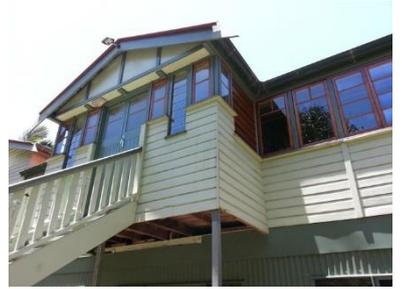
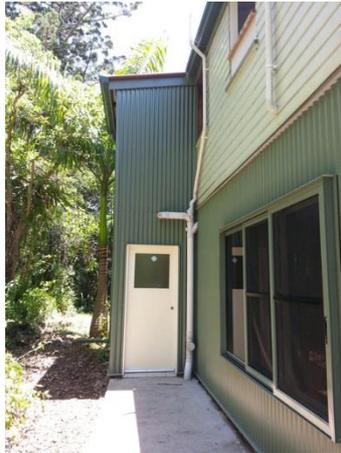
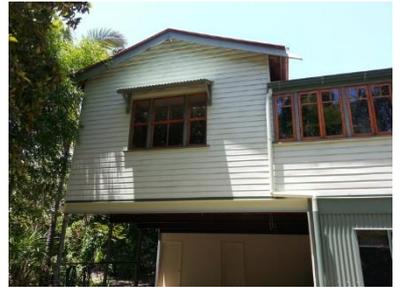
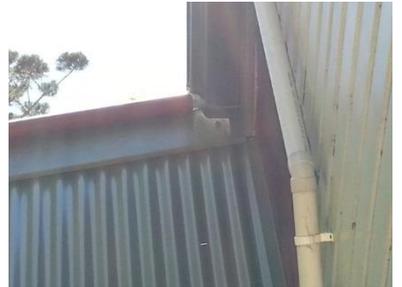
Overall condition: acceptable/fair

- **Roof Covering** - fair
 - Corrugated metal roof covering
 - There appears to be deterioration of the paint finish to the roof sheeting and in some areas the paint finish has been removed by tree branches brushing against the roof sheet – consideration may be given to re-coating the roof

- **Gutters, Downpipes, Flashing** - acceptable/fair
 - Some areas of the roof do not appear to be adequately guttered particularly at internal wall corners. The barge rolls do not end in the gutters – recommend consultation with a licenced roof plumber for further assessment

- Some of the downpipes require downpipe brackets to fix the downpipes to the walls and post
- **Eaves, Fascia and Barge Ends** - acceptable/fair
 - There is an area at the junction between the kitchen roof and the verandah roof that is incomplete requiring repair

- Some of the eaves appear to require blocking to prevent access by vermin
- **Vents & Flues** - not inspected, I cannot apply a condition
