# 8 Dolphin Street YEPPOON QLD 4703

Report Prepared: 19-Jan-22  
Inspector: Karen Logan  
QBCC Licence: 79725

# BUILDING REPORT

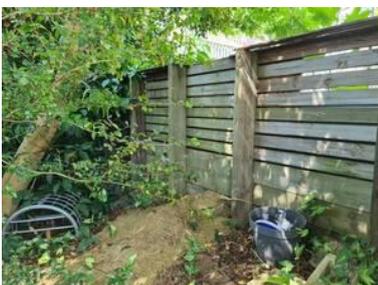
- Comments –
  - There is significant deterioration to the L/H side fence that would benefit from repair
  - There is damage to the R/H side gate requiring repair

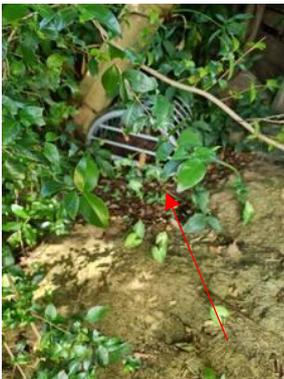
- Comments –
  - Surface water most likely flows through the yard toward the drain located at the rear L/H corner of the property – the fencing applied to the area at the rear of the building to the rear boundary fence appears to prevent water flow to the drain – highly recommend consultation with a structural landscaper or licenced plumber for further assessment and recommendation to ensure water is adequately diverted to the drain in order to prevent further building subsidence, damage to the building elements and attraction of termites
  - The downpipes dispersing water directly beside the building would benefit from further diversion to prevent building subsidence, damage to the building elements and attraction of termites

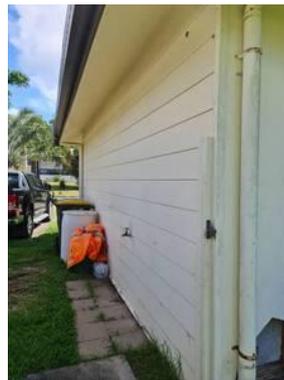
- Comments –
  - There is visible evidence of termite activity in several areas of the building – further invasive inspection would be required to determine the extent of the damage and a course of action as required – also highly recommend consultation with a licenced timber pest specialist for further assessment and recommendation
  - There is damage to the ant capping at the base of the walls that would benefit from repair – an alternative termite barrier could be a consideration
  - There is damage to the wall cladding at the rear of the bathroom requiring repair – further invasive inspection would be required to determine the extent of the damage and a course of action as required - there is visible evidence of termite activity in the wall framing – highly recommend consultation with a licenced timber pest specialist for further assessment and recommendation

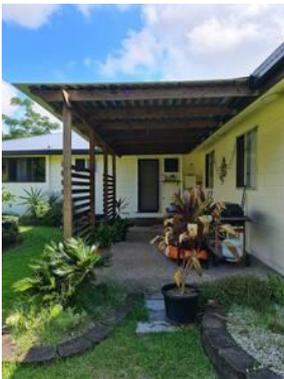
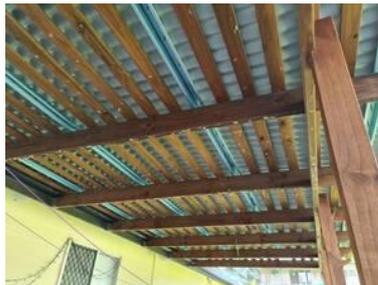
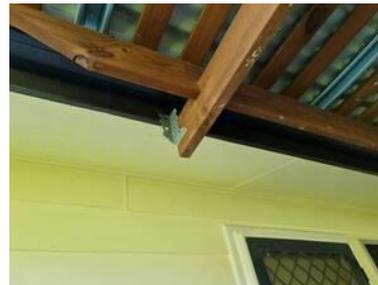
- Comments –
  - The pergola structure appears to have been constructed for a slat roof only – the installation of roof sheeting most likely requires the structure to be upgraded to prevent uplift during serious weather events – highly recommend consultation with a structural engineer to determine structural adequacy
  - The installation of a gutter and drainage would be beneficial to adequately divert water away from the building

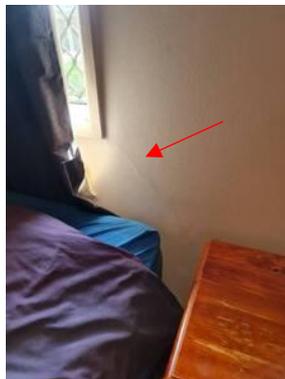
- Comments –
  - There is some evidence of movement cracking in the wall linings requiring repair – consultation with a structural engineer would be required to determine the significance of the cracking and a course of action as required – also see 'Subfloor'

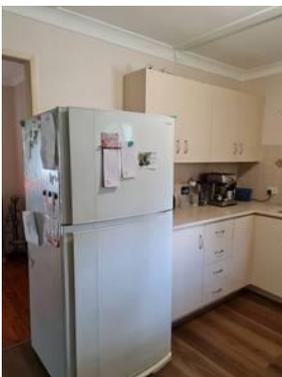
- Appliances (not tested)
  - upright electric stove
  - rangehood
  - dishwasher
- Cabinets - **acceptable**
- Benchtop - **acceptable**
- Splashback - **acceptable**
- Comments –
  - The junction between the benchtop and splashback would benefit from sealing to prevent damage to the benchtop, cabinets and walls
  - There is damage to the paint finish to the ceiling lining and cornice requiring repair

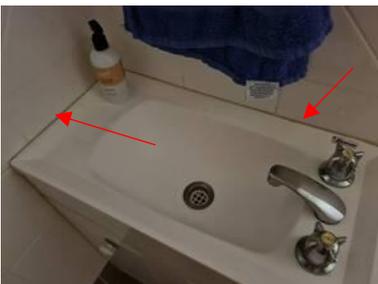
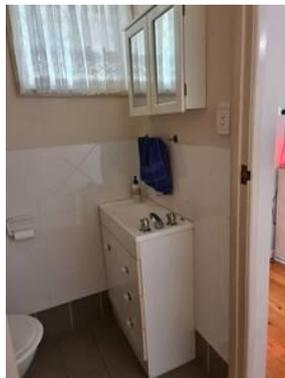
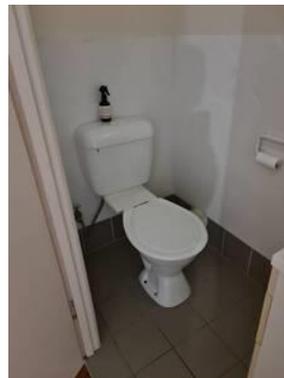
- Comments –
  - The junction between the vanity top and splashback tiles would benefit from sealing to prevent damage to the vanity

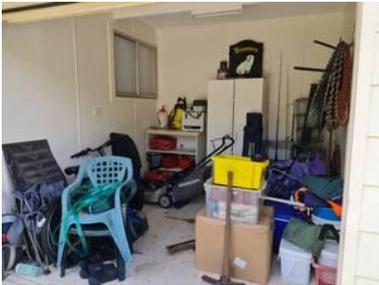
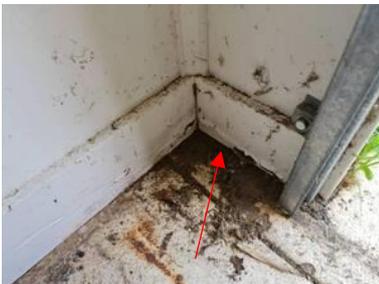
- Comments –
  - There is evidence of termite activity in the skirting board and to the top of the wall adjacent to the roller door – further invasive inspection would be required to determine the extent of any damage and a course of action as required – highly recommend consultation with a licenced timber pest specialist for further assessment and recommendation
