20 Smith Road
COOEE BAY QLD 4703

Report Prepared: 18 January 2014
Inspector: Karen Logan

Building Report

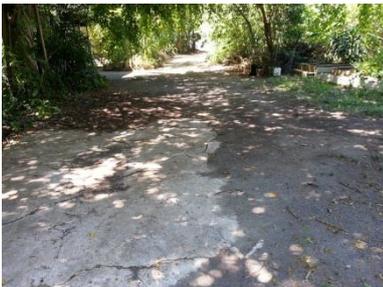
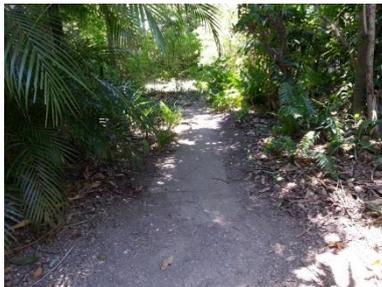
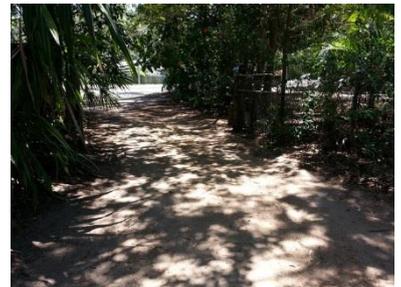
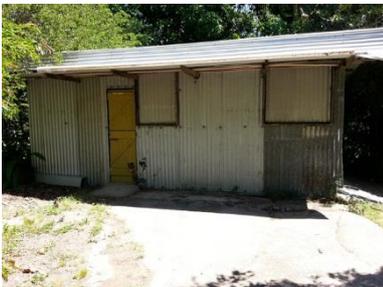
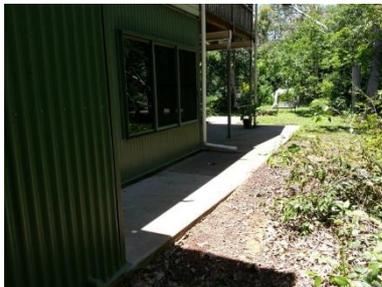
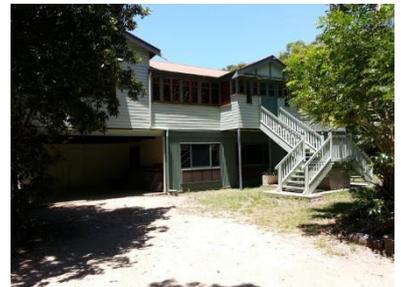
Overall condition: partially inspected – foliage reduced ability to inspect

- Comments -
 - The retaining wall on the R/H side of the property does have some significant deterioration requiring repair

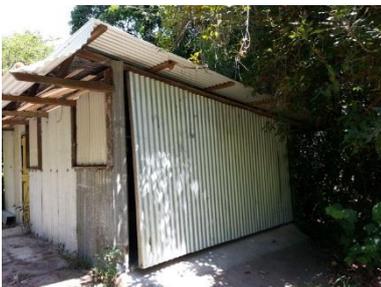
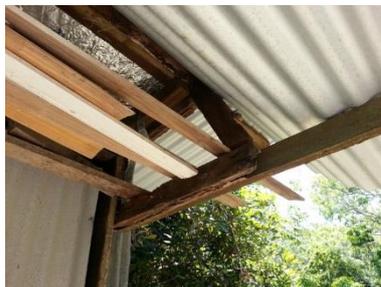
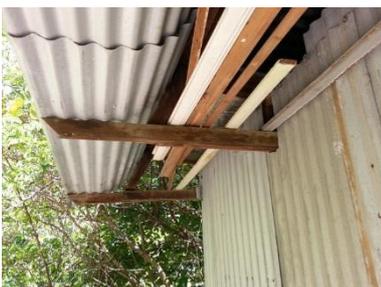
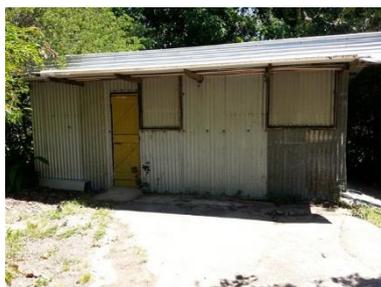
Overall condition: fair

- Comments -
 - The structure appears to require additional fixings and some repairs – recommend consultation with licenced builder for further assessment and repair

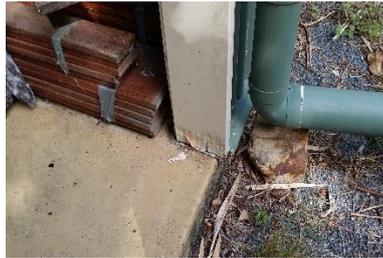
- Comments -
 - There is some deterioration of the timber architrave, skirting & jamb requiring repair

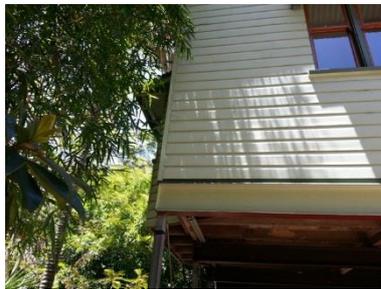
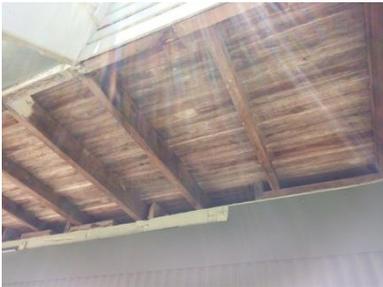
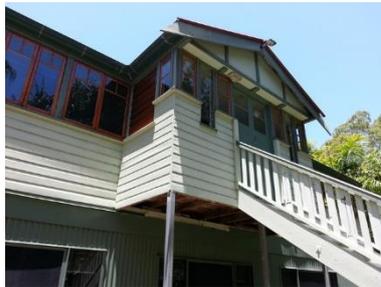
- Comments -
 - The installation of blocking between the joists at the area under the front upper floor entry and the rear verandah would be beneficial to prevent access by vermin to the lower floor ceiling
 - There is some minor deterioration of the weather boards at the external corners – recommend maintaining paint finish to prevent further deterioration

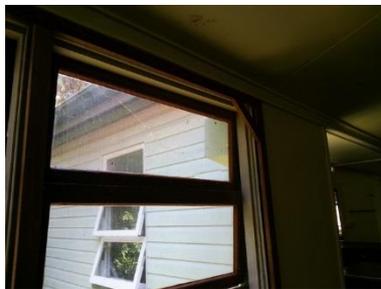
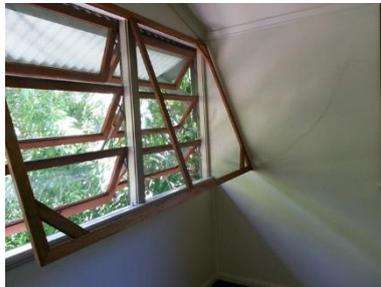
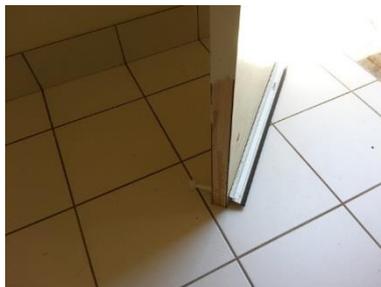
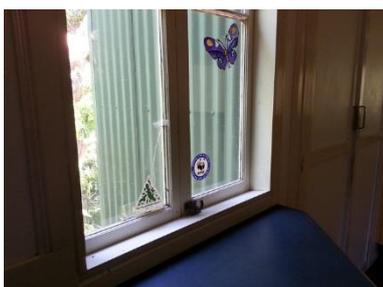
- Comments -
 - There are missing windows to the upper floor toilet, enclosed verandah & bathroom requiring installation to prevent water from entering the building
 - There is broken glass to the windows at the dining area & kitchen requiring repair
 - There is missing window latches to the kitchen windows facing the verandah
 - The flyscreen frame is binding on the wall at the dining room
 - There is door furniture missing to the door opening from the dining room/stairs to the verandah that would benefit from installation
 - The door from the laundry requires painting
 - The front entry door lock to the upper floor was not operational at the time of inspection requiring repair

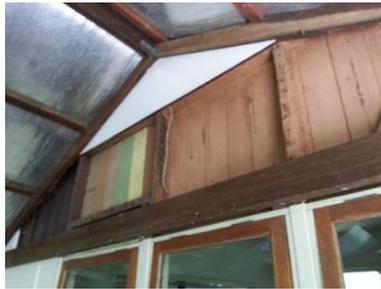
- Comments -
 - There is a baluster missing to the balustrade requiring installation
 - The gable end over the kitchen windows is incomplete requiring completion
 - The joists protruding from the verandah would benefit from cutting for aesthetic purposes

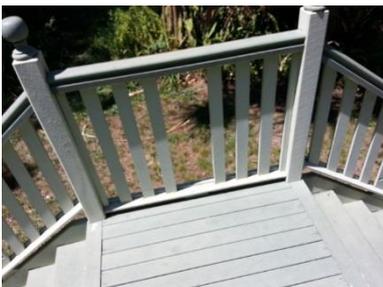
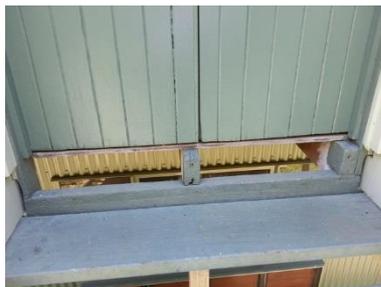
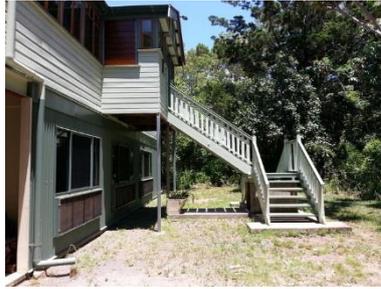
- Comments -
 - There is a baluster missing requiring installation
 - There is some minor deterioration of the base of the post at the landing that would benefit from repair
 - The newel posts are cracked at the base of the stairs – recommend monitoring for any further deterioration or movement and repair as required
 - The top of the stairs at the entry doors requires the installation of a nosing board for completion

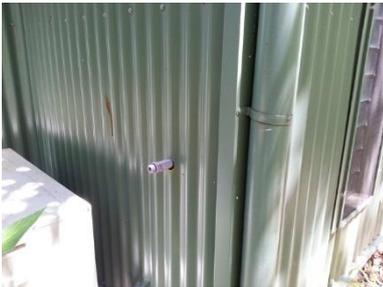
- Comments -
 - There is a temporary tap fitting outside the lower floor toilet requiring completion – installation of tap and flange over the pipe penetration to prevent water from entering the wall

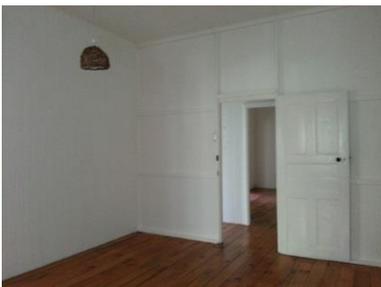
- Comments -
 - There is damage and excessive flex in some of the flooring most likely caused by damage to the tongue and grooves of the flooring boards that may not withstand heavy point loads – recommend consultation with a licenced builder for further assessment and repair as required

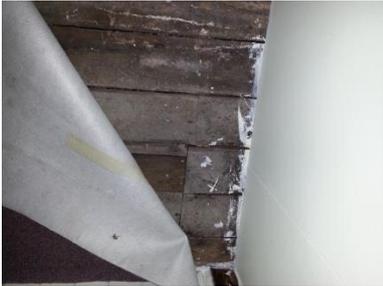
- Comments -
 - There is some previous termite damage to the flooring requiring repair
 - Generally the floor boards are rough sawn causing the floor to be of an uneven finish with excessive gaps which may allow water and dust etc. to affect the ceiling below – consideration may be given to replacing this flooring

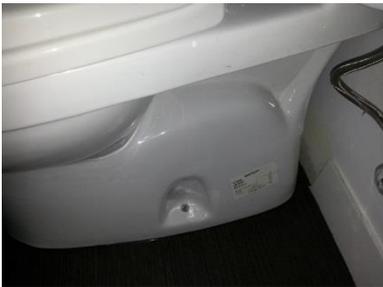
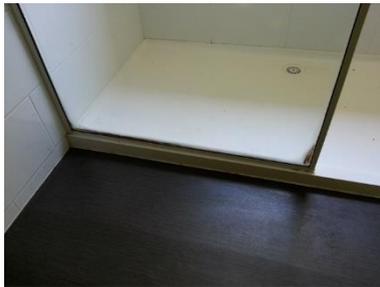
- Comments -
 - This bathroom appears to have been recently renovated however it appears that no consideration has been made for waterproofing – the area appears to rely heavily on the seals around the vinyl floor covering to prevent water from affecting the ceiling below, the flooring & timber bearers & joists and the adjacent flooring in the enclosed verandah – regular monitoring of the seals and vinyl would be required to prevent water damage
 - Generally a window is required to prevent water from entering the building
 - There is a tile missing behind the toilet that would benefit from installation

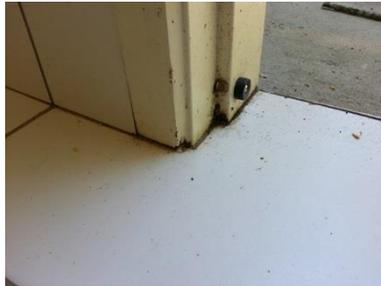
- Comments -
 - There is some deterioration of the architrave at the base of the door jamb requiring repair

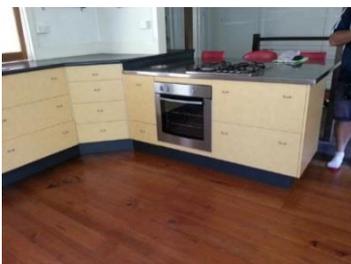
- Appliances - not tested -
 - under bench oven
 - gas cook top
- Cabinets - acceptable
- Benchtop - acceptable
- Splashback - acceptable
- Comments -
 - Some areas of the walls, posts and cabinets are un-painted and would benefit from completion
 - Also see 'External Doors and Windows'

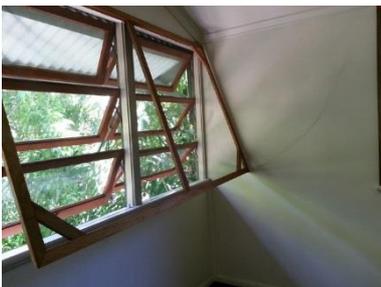
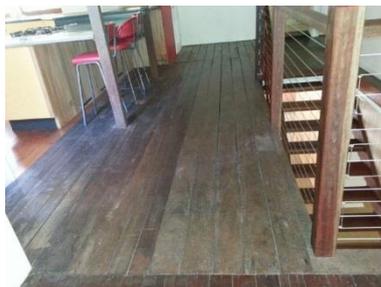
- Comments -
 - The flyscreen frame is binding on the window requiring repair
 - The wall over the internal stairs requires patching and re-painting
 - Generally the floor boards are rough sawn causing the floor to be of an uneven finish with excessive gaps which may allow water and dust etc. to affect the ceiling below some of the boards are loose and or damaged requiring repair – consideration may be given to replacing this flooring

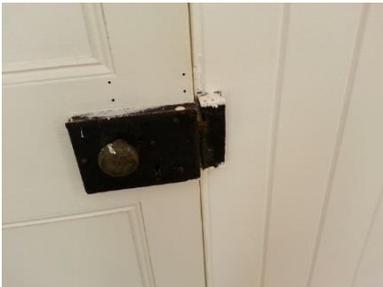
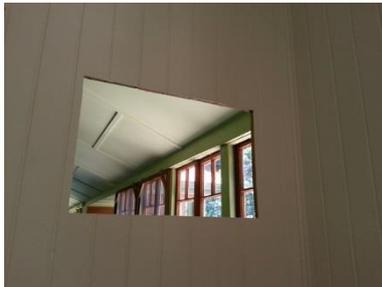
- Comments -
 - The door furniture requires adjustment for effective operation
 - There is a hole cut in the wall lining that would benefit from finishing mouldings

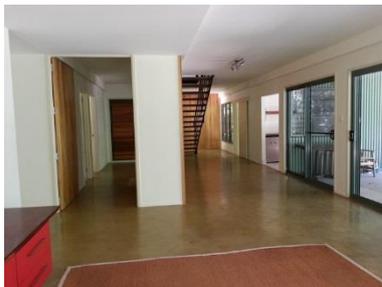
- Comments -
 - There is some delamination of the door to the study nook caused by the hinge screws requiring repair
 - There are some significant cracks to the concrete floor– recommend monitoring these cracks for any further deterioration

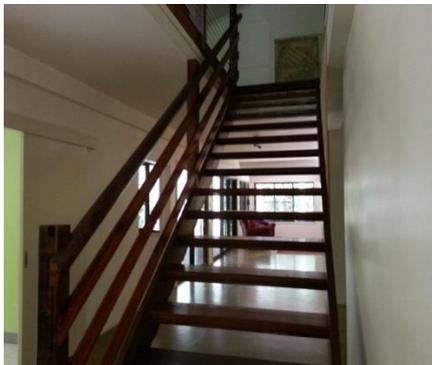
- There is a significant lip to the flooring (pictured below) that would benefit from repair
 - Generally the french doors have only been partially re-painted. Some of the doors require new putty to be installed and there is a missing glass pane to the door for bedroom 2 requiring replacement. Most of the doors require the installation of door latches etc.

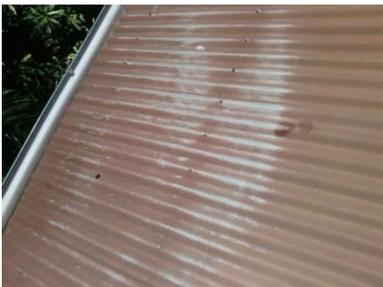
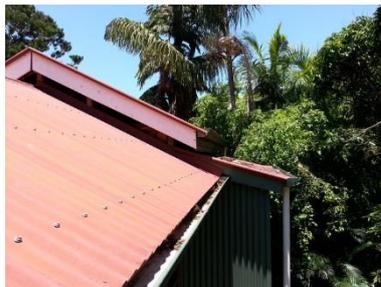
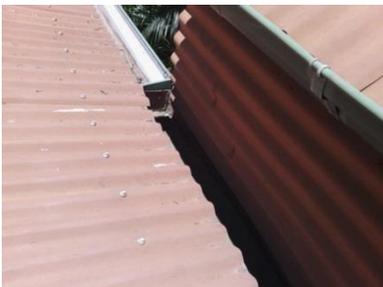
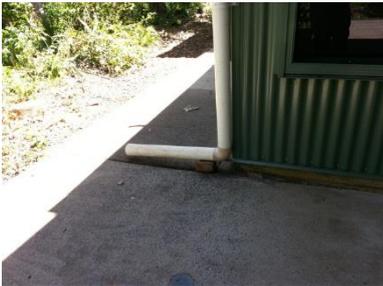
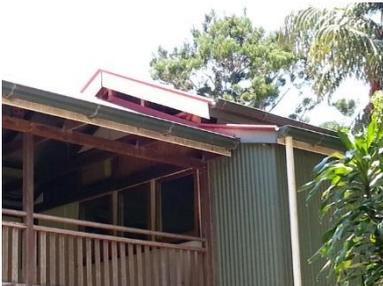
- **Roof Covering** - fair
 - Corrugated metal roof covering
 - There appears to be deterioration of the paint finish to the roof sheeting and in some areas the paint finish has been removed by tree branches brushing against the roof sheet – consideration may be given to re-coating the roof

- **Gutters, Downpipes, Flashing** - acceptable/fair
 - Some areas of the roof do not appear to be adequately guttered particularly at internal wall corners. The barge rolls do not end in the gutters – recommend consultation with a licenced roof plumber for further assessment

- Some of the downpipes require downpipe brackets to fix the downpipes to the walls and post
- **Eaves, Fascia and Barge Ends** - acceptable/fair
 - There is an area at the junction between the kitchen roof and the verandah roof that is incomplete requiring repair

- Some of the eaves appear to require blocking to prevent access by vermin
- **Vents & Flues** - not inspected, I cannot apply a condition
